G. BRAKE DISC INSPECTION

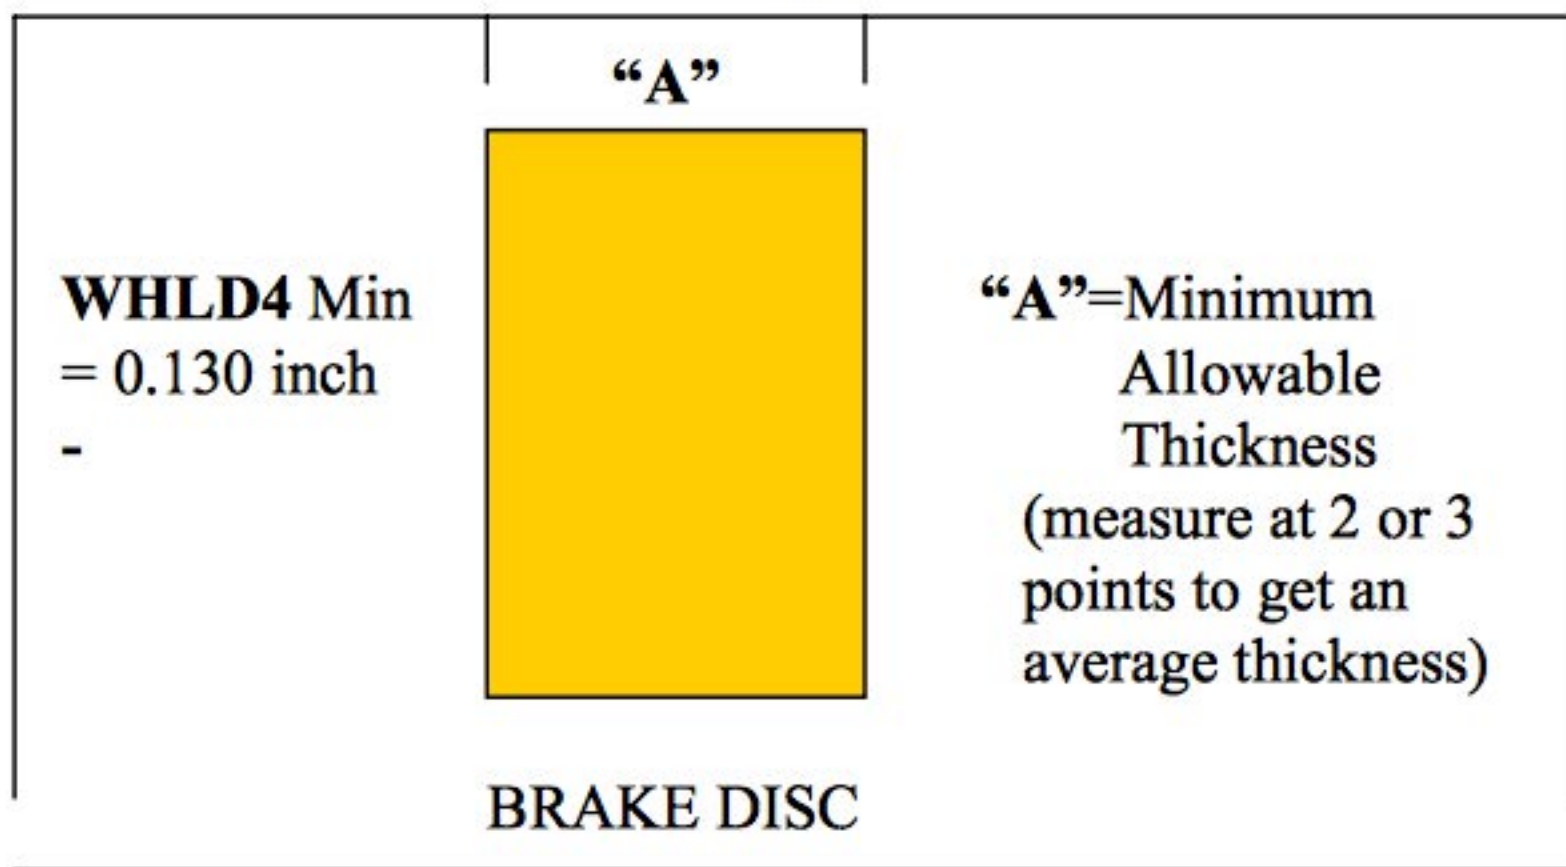
Fig. 6

Rust in varying degrees may form on the exposed portion of the disc. If a powdered rust appears on this surface, one or two braking applications during taxiing should wipe the disc clear. Rust build up beyond this point, may require removal of the disc from the wheel to properly clean both surfaces. A wire brush followed by 220-grit **garnet** paper should restore the braking surface adequately. Do not remove plating in areas that are not contacted by the linings.
